## USE OF VIBRATION DATA FOR RAILWAY TRACK CONDITION ASSESSMENT VIA MOBILE PLATFORMS

**Abstract.** The article presents a comprehensive framework for railway track diagnostics based on the analysis of vibration signals. The principal objective of the study is to acquire detailed, data-driven insights into the actual technical condition of railway infrastructure through a passive experimental approach. This is achieved by utilizing mobile diagnostic platforms and advanced measurement techniques designed to assess the structural state of the track without interrupting regular rail operations. The research outlines the full spectrum of diagnostic procedures carried out in accordance with established railway regulations and emphasizes the advantages and operational capabilities of mobile diagnostics within railway transport systems.

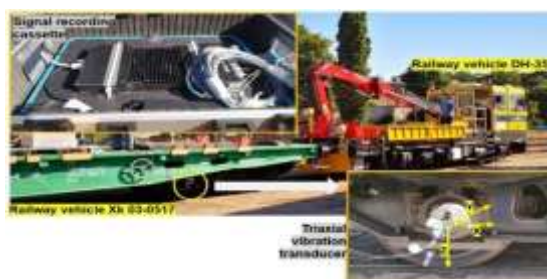
Fig. 1. Mobile measurement set in variant A

For the purposes of this study, two mobile diagnostic configurations were employed on selected railway routes (see Section 3.2). The first configuration (Set A) consisted of a measurement platform of type Xk 03–0517 coupled with a rail vehicle DH–350.11 (Fig. 1). The second configuration (Set B) incorporated the same Xk 03–0517 platform but included an additional separating wagon positioned between the platform and the DH–350.11 rail vehicle (Fig. 2).

The measurement platform Xk 03–0517, with buffers, has an overall length of 12.240 m. It is constructed as a two-bogie vehicle, each bogie equipped with two axles and flanged wheels, and it operates without an independent propulsion system. The platform has a mass of 17,850 kg. The second element of the diagnostic set is the DH–350.11 hydraulic rail vehicle, measuring 12 m in length and equipped with a 350 kW drive engine, capable of reaching a maximum speed of 80 km/h.

sampled at a frequency of 51.2 kHz. The accelerometers were mounted on the bearing housings (axle boxes) of the second wheel of the first bogie, on both the left and right sides of the rail platform (Fig. 1).

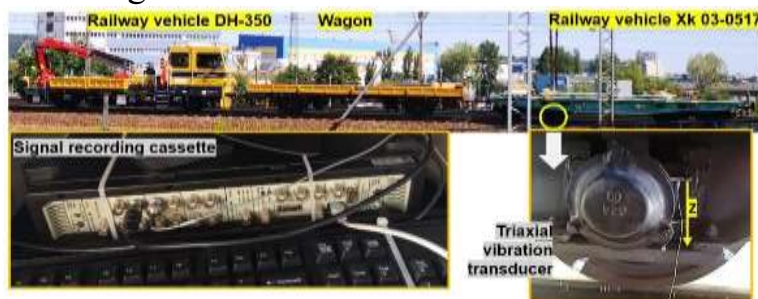
Fig. 2. Mobile measurement set, variant B

Measurement set B comprised two 4508-type single-axis accelerometers coupled with a 7533 B&K signal recording unit. The accelerometers were installed beneath the upper shelf of the lateral section of the axle box on the second wheel of the first bogie, aligned with the direction of platform travel, and mounted symmetrically on both sides of the railway platform (Fig. 2).
